The Parish of Dunkerton and Tunley: Flooding Briefing Note

November 2016

DUNKERTON AND TUNLEY PARISH - FLOODING BRIEFING NOTE

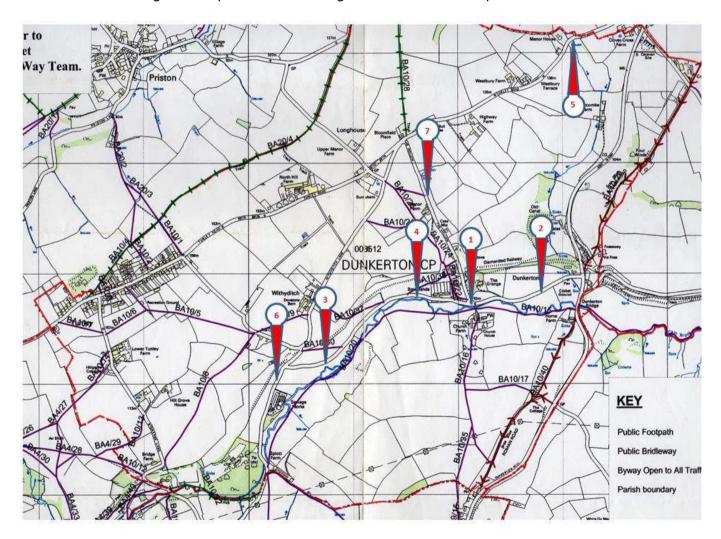
The areas of regular and predictable flooding are shown on the map of the Parish:

1. The Bridge at Dunkerton All Saints' Church (ST711593): flooding here during prolonged periods of heavy rain can be severe with a wide, deep, fast and turbulent flow. A bridge crossing is then potentially and unpredictably hazardous, even in a 4x4. The residents in the houses around the Church are usually cut off for the duration of the flooding unless they fancy a half mile uphill hike over saturated fields on the footpath towards Peasdown St John. Fortuitously, there has been no damage to nearby residential property in living memory.

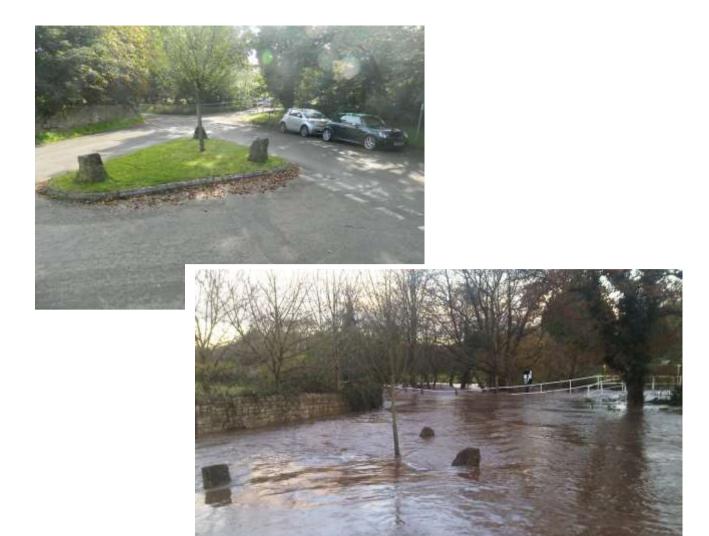
Typical Flooding Event at the Bridge

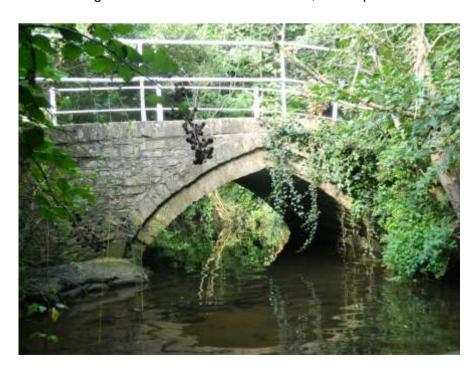
Main Cause: high rates of flow towards the small, fixed aperture.

Very old, very lovely, but very small

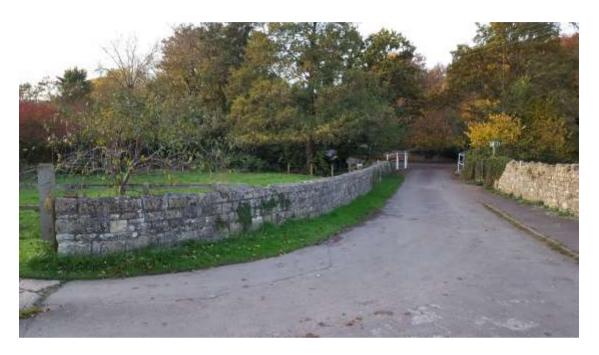
Contributory Factors: adjacent stone walls running south from the bridge, punctured by purpose built but very small drainage holes, act as perfect dams to prevent flood waters flowing on down the valley!

Stone walls hold back any water over-topping the brook trying to drain (left to right in the picture) through the bridge where the white railings are

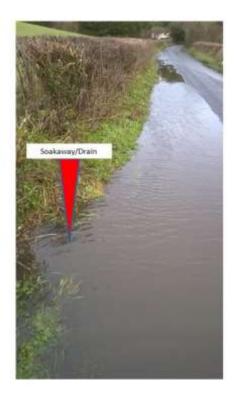
Main Cause: the persistently blocked or very low capacity drain (is this a soakaway?) 130m west of the cricket club gate

Ponding to half of the width of the lane caused by the blocked drain/soakaway after only a moderate spring rainfall

- Flooding at the Bridge: B&NES Action: Clear the drains down the length of the Hollow before winter
- Church Lane to A367: B&NES Action 1: Clear the troublesome 130m drain/soakaway before winter. B&NES Action 2: Survey the ineffective drains proud of the surface behind the cricket club – are there any remedial options?
- Church Lane to A367: Local Action: seek our Highways Inspector's view about getting the drain/soakaway annotated as a "Special Attention" drain.

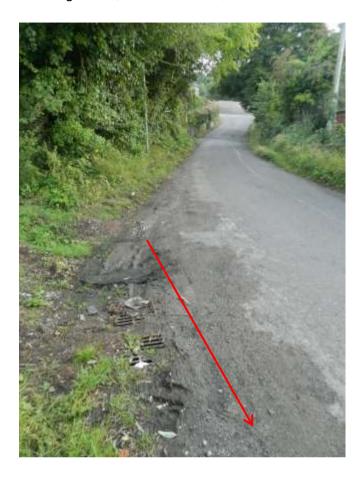
Contributory Factors: a stream overflow and run-off from the east onto the lane and flowing round, rather than into, the drains near cricket club

A stream normally flows under the lane left to right where the 2 poles are. Witness marks on the tarmac here opposite the gate to the cricket ground reveal where the over-topped stream and other run-off flowed over and past the drains and on down the lane towards the blocked soakaway (above)

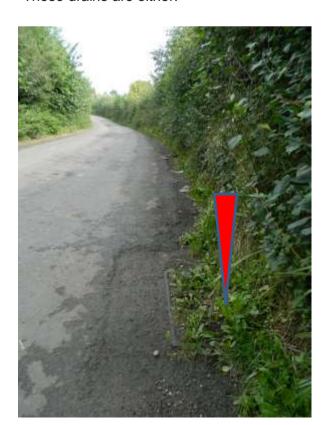
Main Cause: the series of drains from Withyditch down to and past Engine Bridge. These drains are either:

regularly and persistently silted up

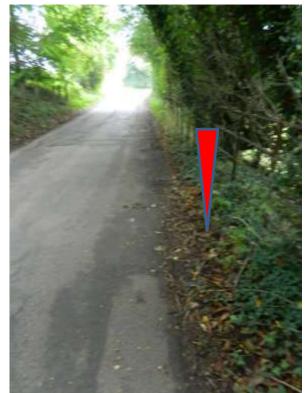
or blocked with debris

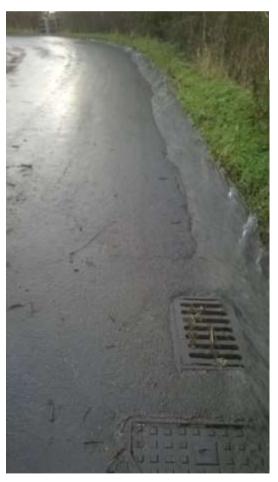
or sitting proud of road surface - the run-off just bypasses the drain

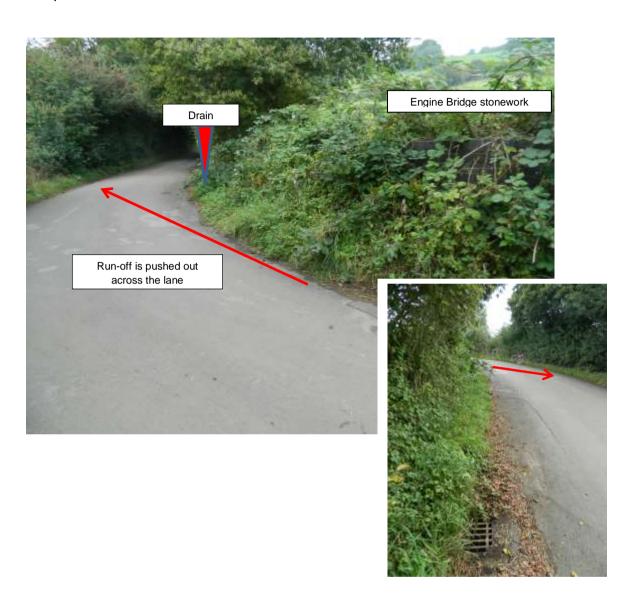
Contributory Factors: At Engine Bridge, the northern road verge has grown out over the years, diverting the run-off from Palmer's Lane (there are no drains higher up the valley on Palmer's Lane) away from the drain and across the carriageway. This diverted flow away from the drain is encouraged by the significant adverse camber at this point.

Church Lane to the West: B&NES Action 1: Cut back the northern verge round and below Engine Bridge to re-establish the run-off from Palmers Lane round Engine Bridge down into the existing drain. B&NES Action 2: Withyditch Lane – clear the drains and gullies before winter Gates to Field: B&NES Action 1: Survey the drain taking water from the perpetual spring down to the Brook and clear any blockage to re-establish its design capacity.

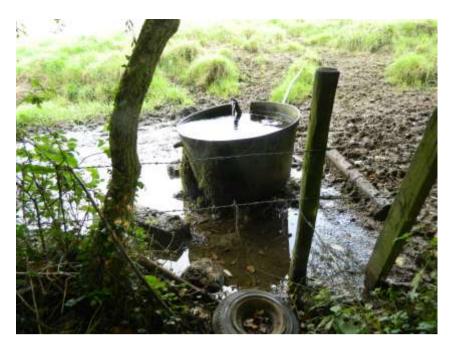
Main Cause: A perpetual spring empties into drain to the Brook. The drain serving the spring at the section across the lane towards the brook is partially blocked and so of low capacity. This quickly backs up during periods of prolonged rainfall. The next drain sits proud of the surface and the water overflowing the first (blocked) drain runs past it to pond and eventually flow across the lane.

Perpetual spring – cattle drinking water

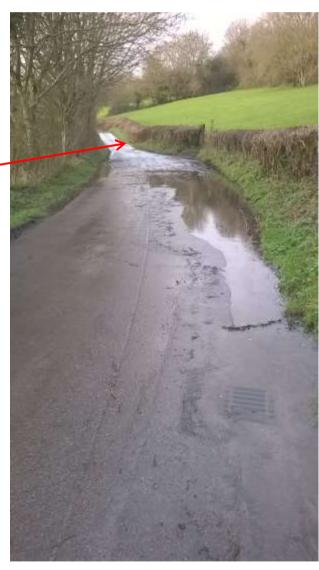
Further contributory factor: A spring to the west along the lane flows during winter to a drain that only discharges at ground level into a field rather than on into the brook. The outflow of the pipe in the field blocks occasionally and, when it does, the drain backs up and the overflow flow worsens any ponding from the perpetual spring

Note the blocked drain and the asymmetric ponding around it. When it is not blocked, at lower rates of flow water is pushed away from it to the right by the adverse camber. It is also slightly proud of the surface.

Gates to Field: B&NES Action 2: Survey the drain here sitting proud of the surface – are there remedial options? Note the same view on page 10 above.

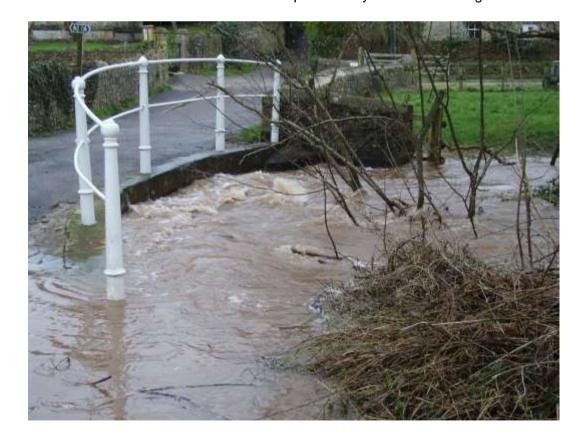
A rise in the level of the brook up to the keystone of the bridge

Here We Go Again!!!....

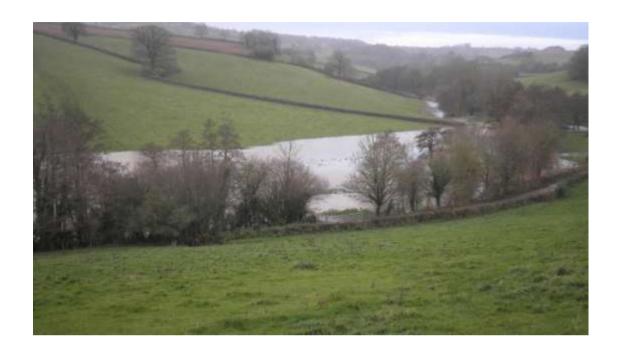
Ponding in the big field at ST707593

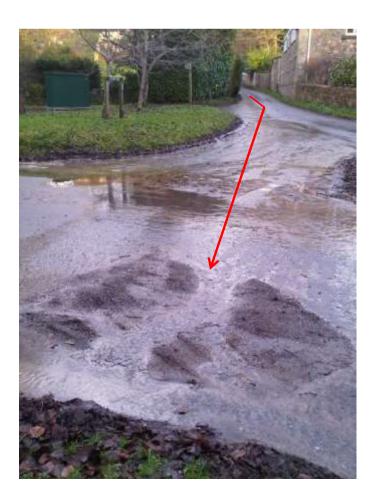
Significant surface water flows over the road at the bottom of The Hollow –
the drains above (up to beyond Manor Farm) are by then usually full to
capacity, or blocked by detritus, and are overflowing

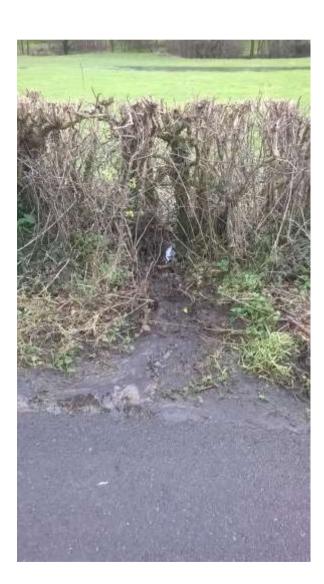
A DIY drainage cut through the verge at the drain/soakaway

• Clear "DIY" drainage cuts through the verges of Church Lane, to allow any ponding to drain away

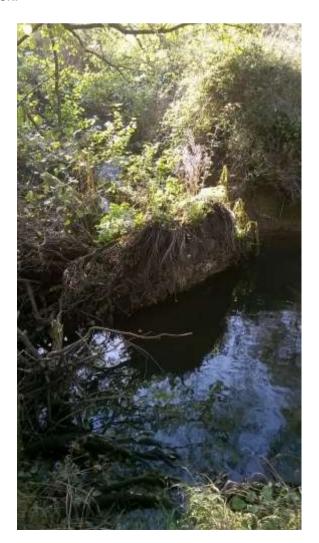
Flooding at the Bridge: Local Action: Retain our "upland water management scheme" – a big landslip 2 years ago pushed several alder trees into the brook at ST704592. Though the usual approach is to clear water courses of obstructions, doing so here would simply get more water downstream to the bridge, quicker. Flooding will inevitably happen quicker, and last for longer. The fallen trees act as a natural porous barrier slowing down surge flows in the brook.

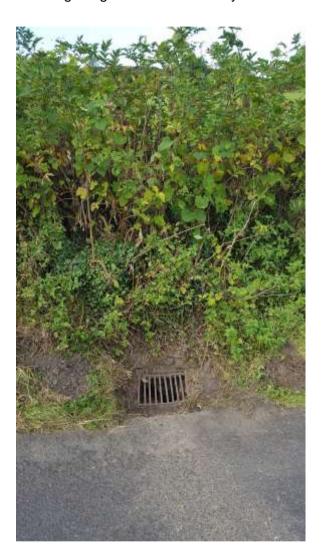
Excellent clearance of the troublesome drain/soakaway by the BANES drainage team, Sep 16

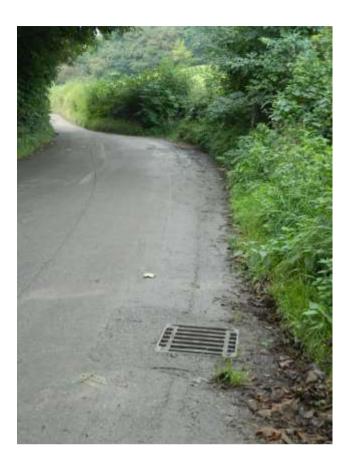
Manor House bend: Local Action: Check the drain cover is clear
