**The Parish of Dunkerton and Tunley:
Flooding Briefing Note
Issue 2 (Updated July 2017)**

DUNKERTON AND TUNLEY PARISH - FLOODING BRIEFING NOTE

INTRODUCTION

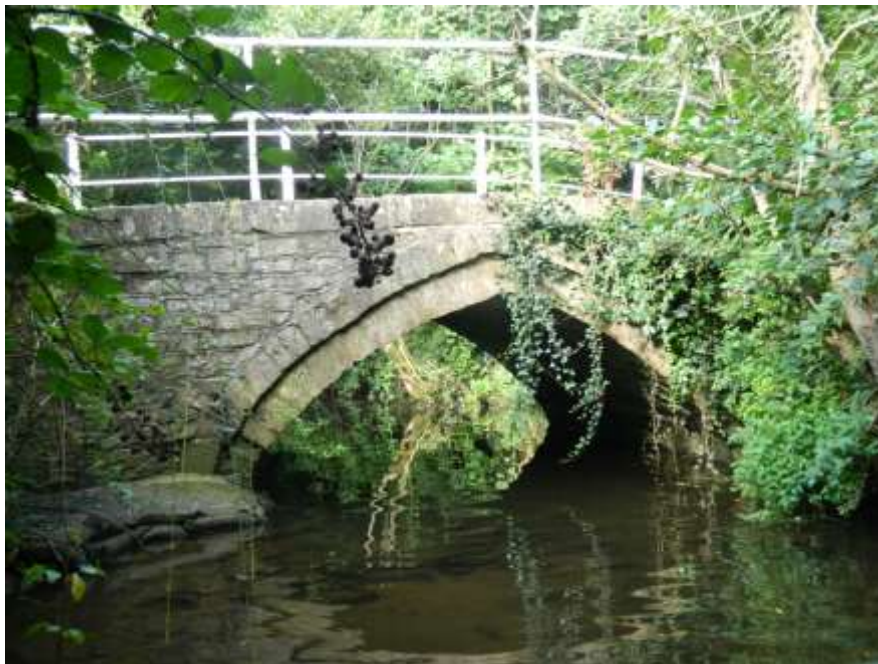
Main Cause: high rates of flow towards the small, fixed aperture.

Very old, very lovely, but very small

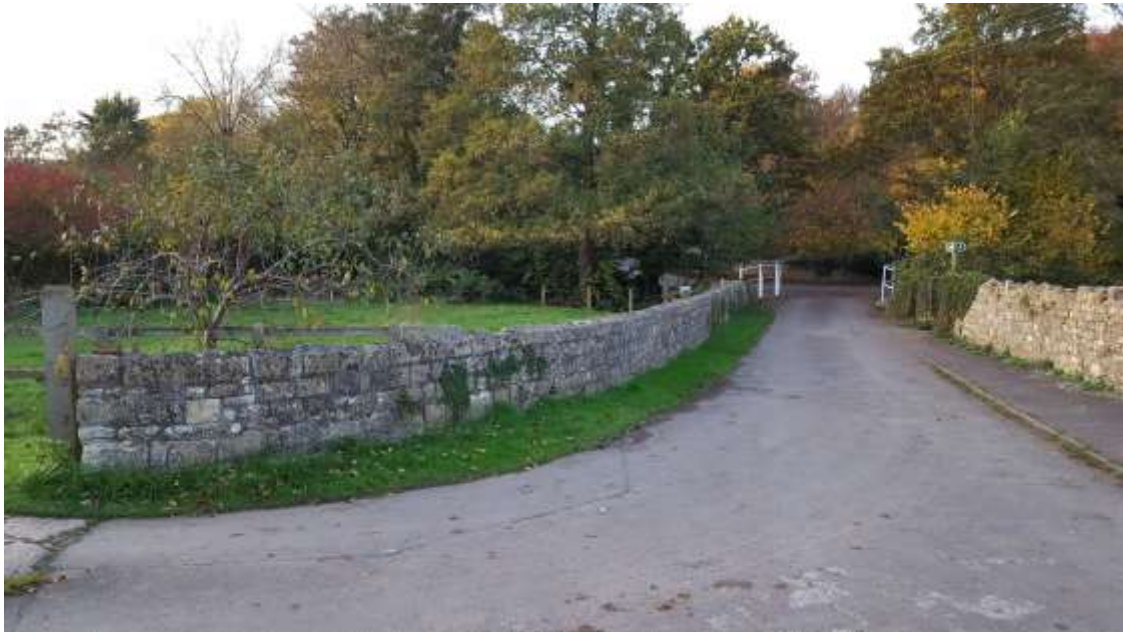
Contributory Factors: adjacent stone walls running south from the bridge, punctured by purpose built but very small drainage holes, act as perfect dams to prevent flood waters flowing on down the valley!

Stone walls hold back any water over-topping the brook trying to drain (left to right in the picture) through the bridge where the white railings are

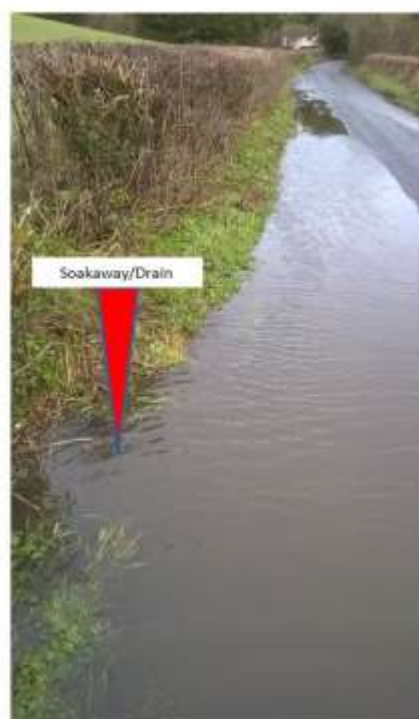
Main Cause: the persistently blocked or very low capacity drain (is this a soakaway?)
130m west of the cricket club gate

Ponding to half of the width of the lane caused by the blocked drain/soakaway after only a moderate spring rainfall

- Flooding at the Bridge: B&NES Action: Clear the drains down the length of the Hollow before winter
- Church Lane to A367: B&NES Action 1: Clear the troublesome 130m drain/soakaway before winter. B&NES Action 2: Survey the ineffective drains proud of the surface behind the cricket club – are there any remedial options?
- Church Lane to A367: Local Action: seek our Highways Inspector's view about getting the drain/soakaway annotated as a "Special Attention" drain.

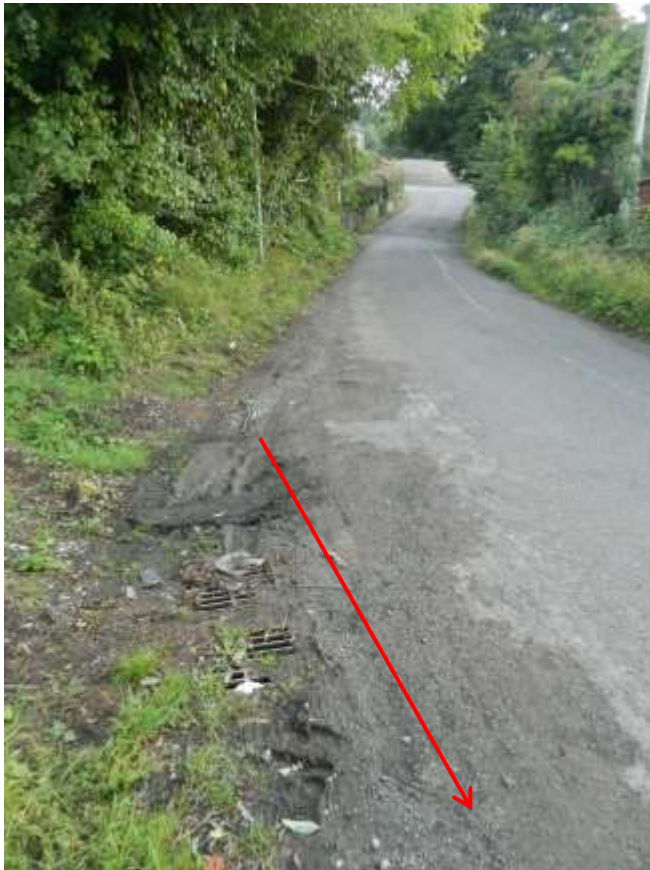
Contributory Factors: any stream overflow and run-off from the east onto the lane and flowing round, rather than into, the drains near cricket club

A stream normally flows under the lane left to right where the 2 poles are. Witness marks on the tarmac here opposite the gate to the cricket ground reveal where the over-topped stream and other run-off flowed over and past the drains and on down the lane towards the blocked soakaway (above)

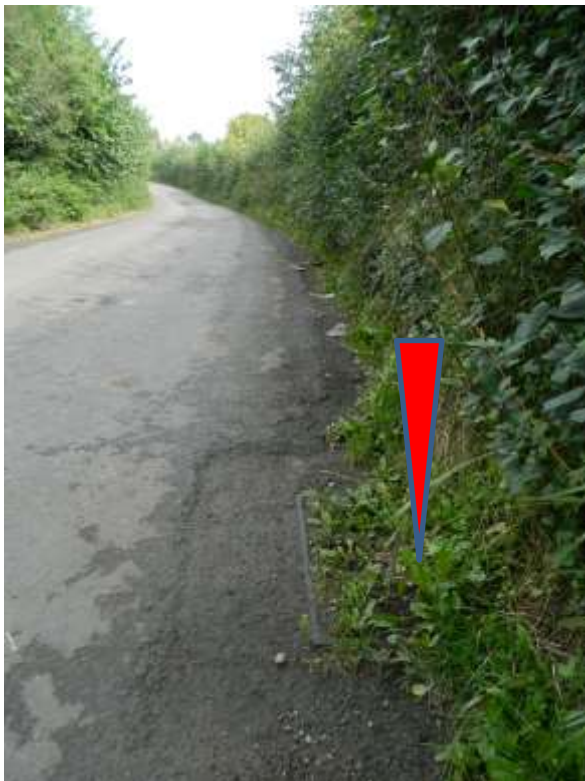
Main Cause: the series of drains from Withyditch down to and past Engine Bridge.
These drains are either:

regularly and persistently silted up

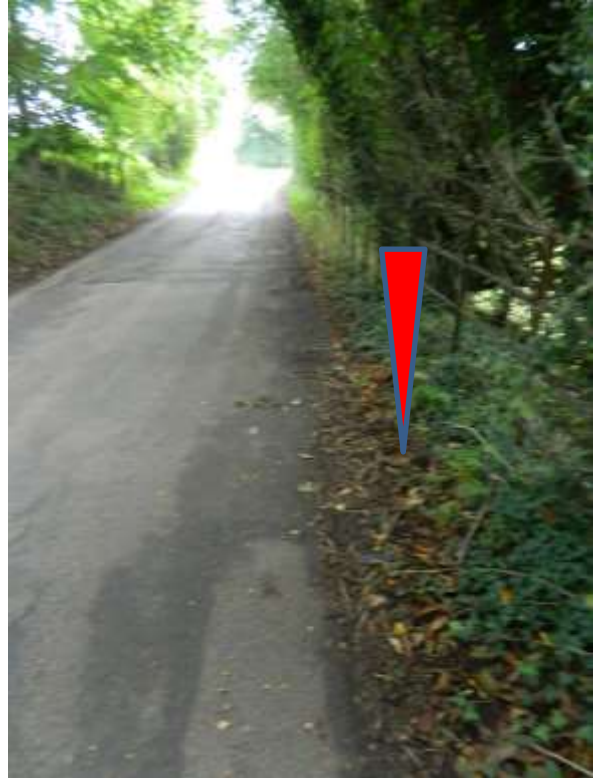
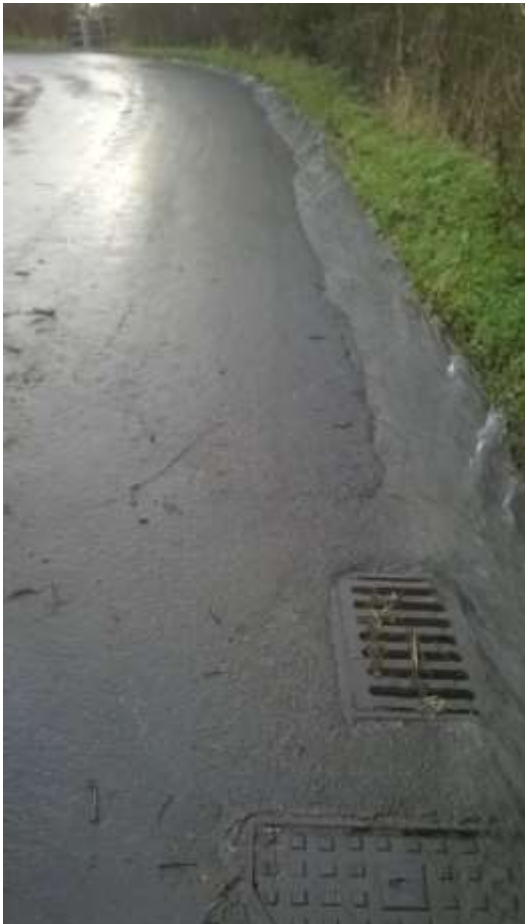
or blocked with debris

or sitting proud of road surface - the run-off just
bypasses the drain

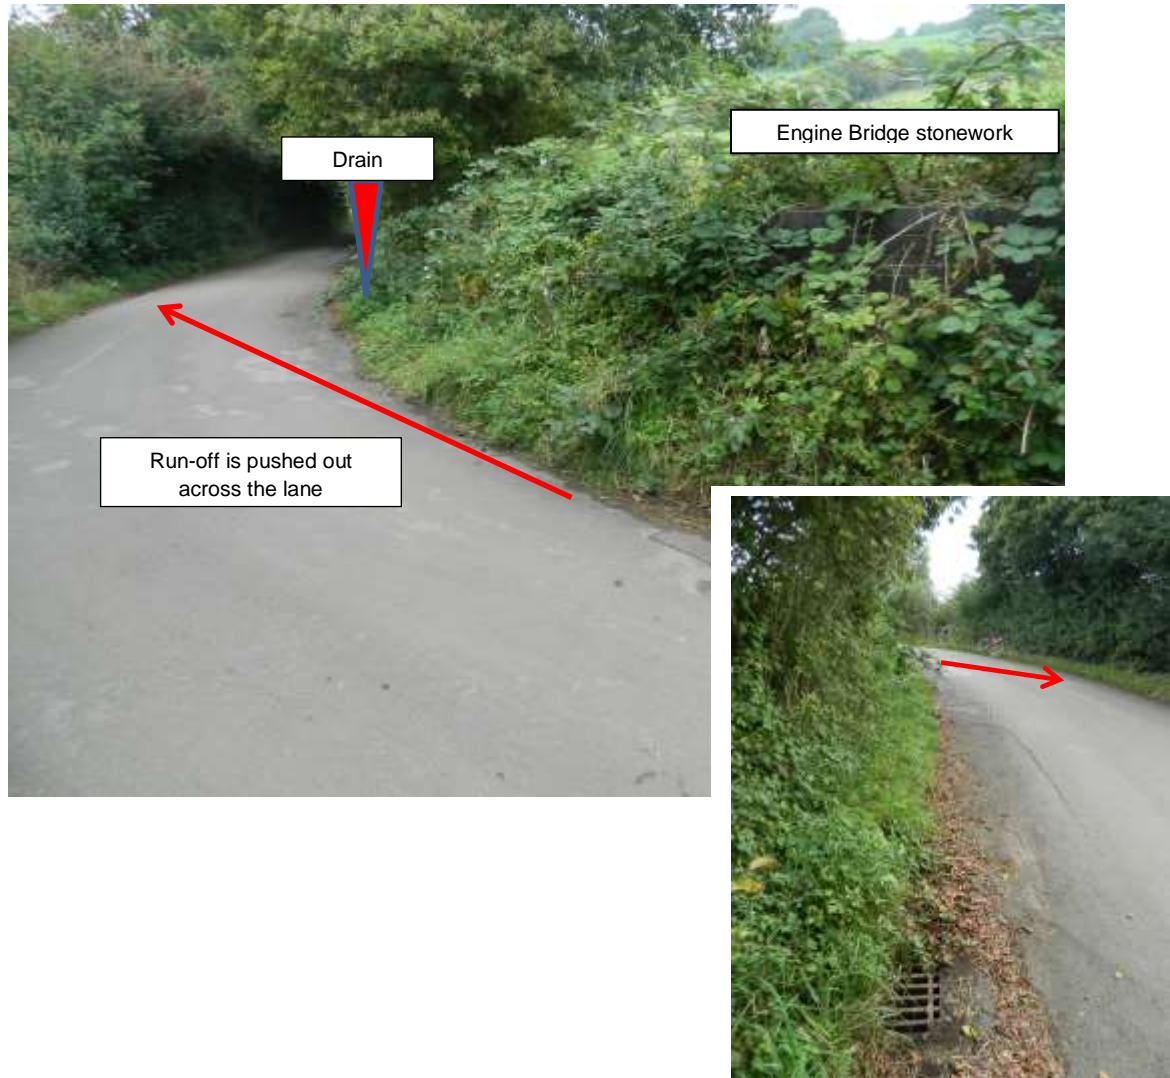
Contributory Factors: At Engine Bridge, the northern road verge has grown out over the years, diverting the run-off from Palmer's Lane (there are no drains higher up the valley on Palmer's Lane) away from the drain and across the carriageway. This diversion of flow away from the drain is encouraged by the significant adverse camber at this point.

- Church Lane to the West: B&NES Action 1: Cut back the northern verge round and below Engine Bridge to re-establish the run-off from Palmers Lane round Engine Bridge down into the existing drain. B&NES Action 2: Withyditch Lane – clear the drains and gullies before winter

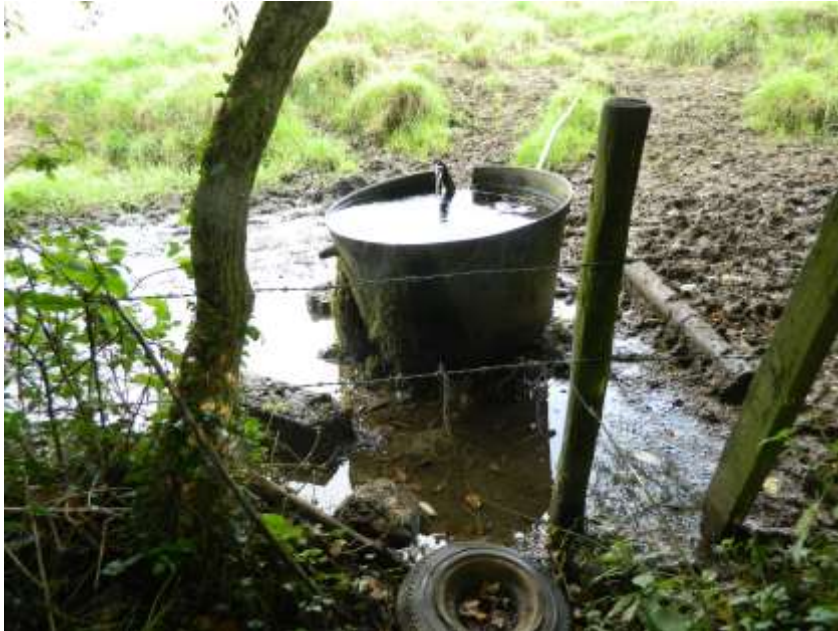
Main Cause: A perpetual spring empties into a drain to the Brook. The drain serving the spring at the section that crosses under the lane to the brook is partially blocked and so of low capacity. This quickly backs up during periods of prolonged rainfall. The next drain sits proud of the surface and the water overflowing the first (blocked) drain runs past it to pond and eventually flows across the lane.

Perpetual spring – cattle drinking water

- Gates to Field: B&NES Action 1: Survey the drain taking water from the perpetual spring down to the Brook and clear any blockage to re-establish its design capacity.

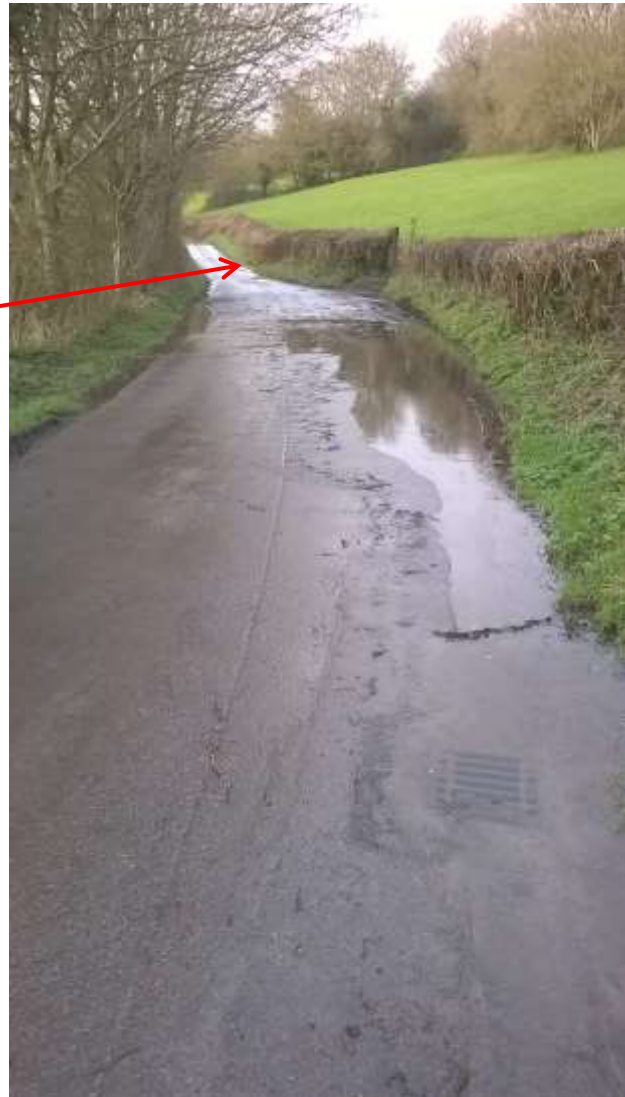
Further contributory factor: A spring to the west along the lane flows during winter to a drain that discharges at ground level into a field rather than on into the brook. The outflow of the pipe in the field blocks occasionally and, when it does, the drain backs up and the overflow flow worsens any ponding from the perpetual spring

Note the blocked drain and the asymmetric ponding around it. When it is not blocked, at lower rates of flow water is pushed away from it to the right by the camber

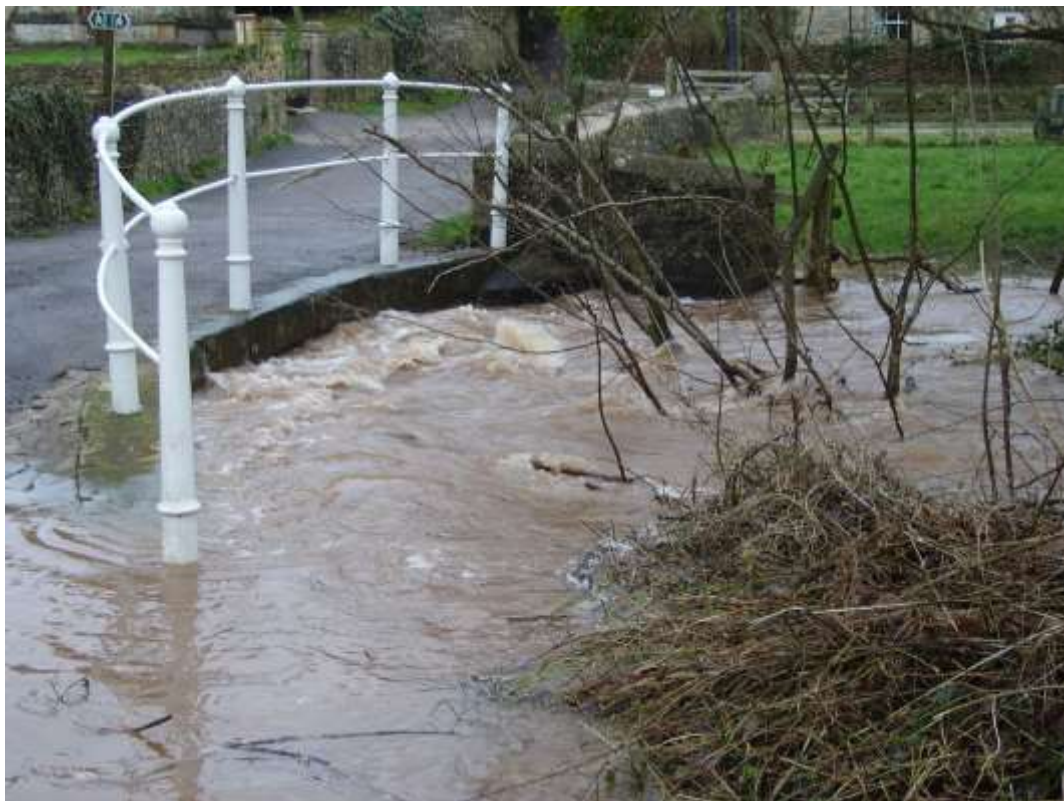
- A rise in the level of the brook up to the keystone of the bridge

Dunkerton Bridge – Flooding Starting

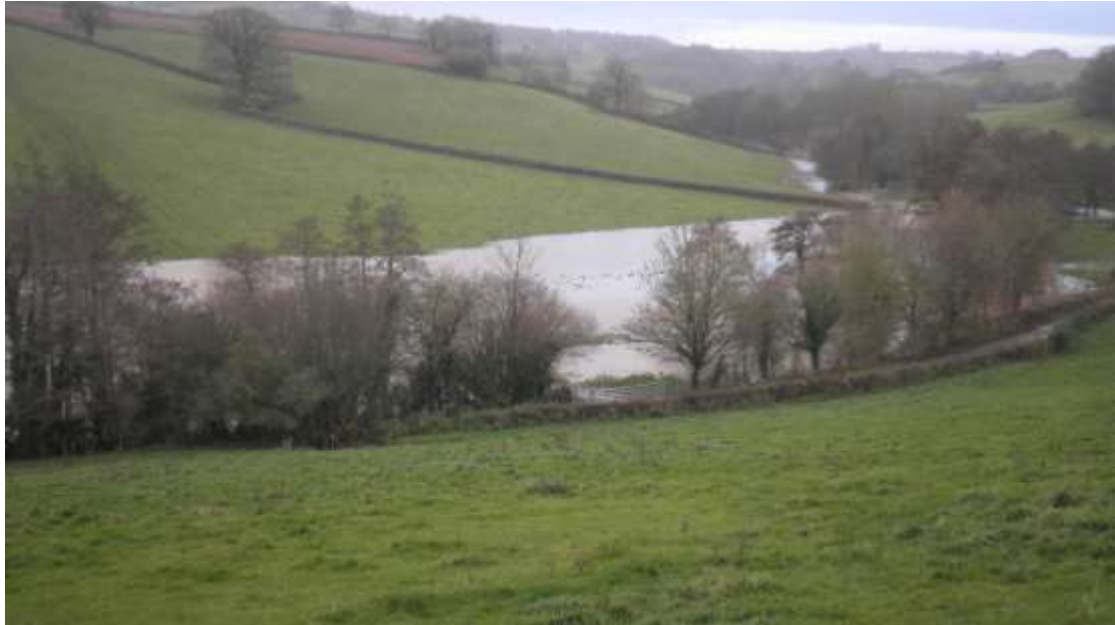
- Ponding in the big field at ST707593

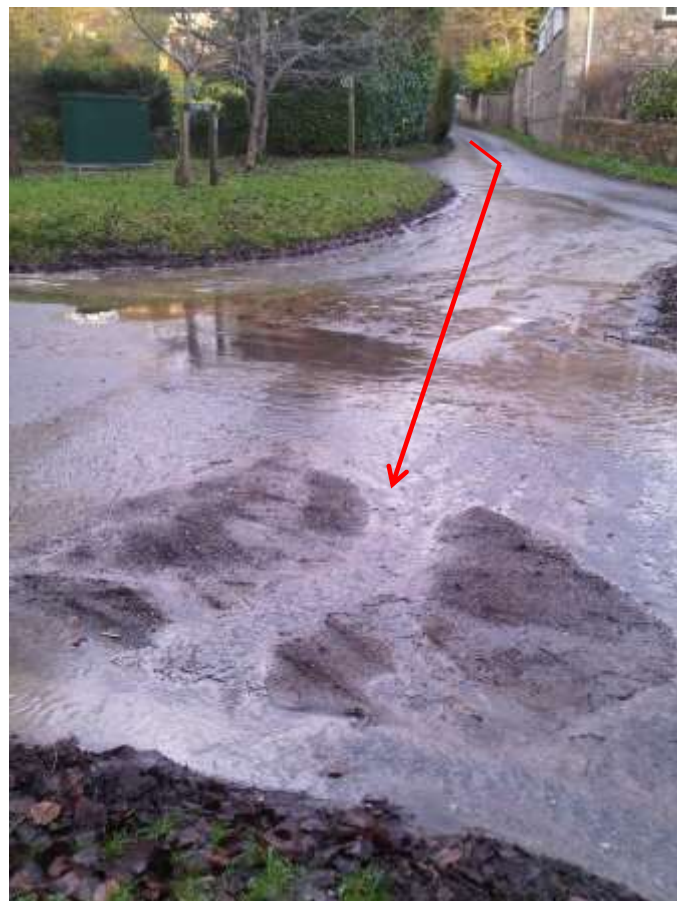
- Significant surface water flows over the road at the bottom of The Hollow – the drains above (up to and beyond Manor Farm) are by then usually full to capacity, or blocked by detritus, and are overflowing

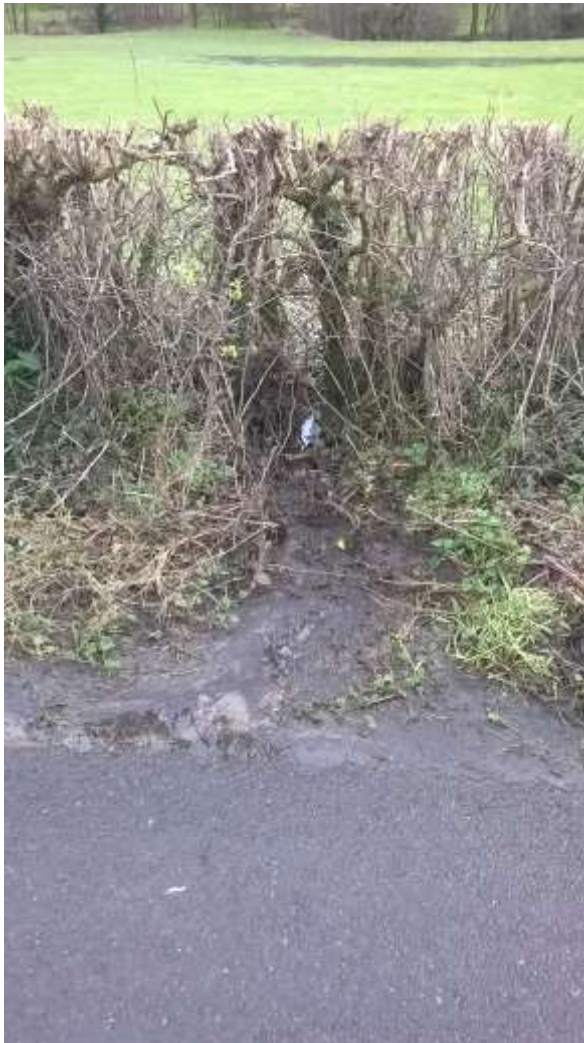
- Clear “DIY” drainage cuts through the verges of Church Lane, to allow any ponding to drain away as it builds up

A DIY drainage cut through the verge at the drain/soakaway

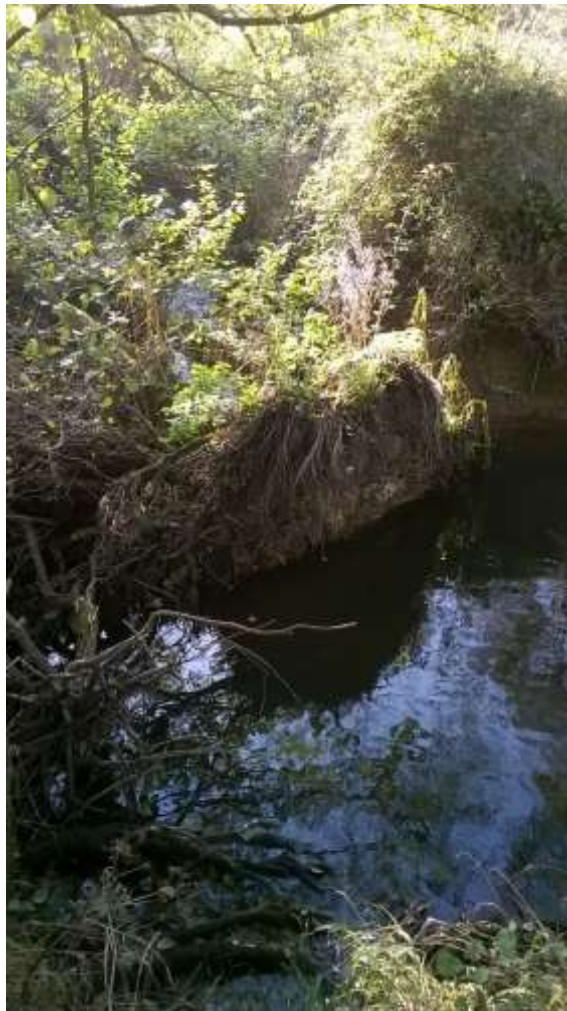
- Flooding at the Bridge: Local Action: Retain our “upland water management scheme” – a big landslide 2 years ago pushed several alder trees into the brook at ST704592. Though the usual approach is to clear water courses of obstructions, doing so here would simply get more water downstream to the bridge, quicker. Flooding will inevitably happen quicker, and last for longer. The fallen trees act as a natural porous barrier slowing down surge flows in the brook.

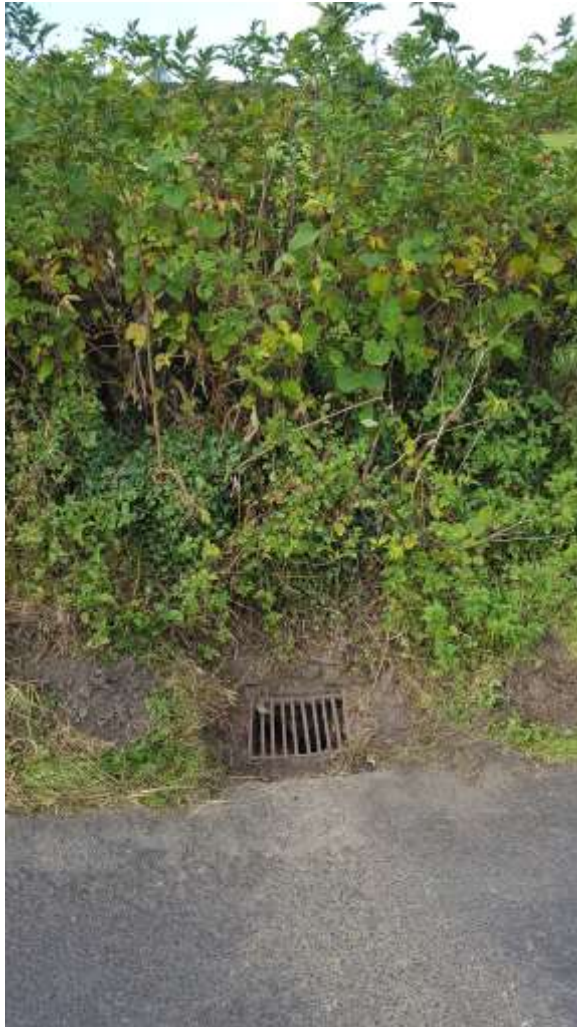
Excellent clearance of the troublesome drain/soakaway by the BANES drainage team, Sep 16
